# Inspection Convertible Gocarz

## M3XWC

11 May 2018 12:38 PM

BMW M3 E46

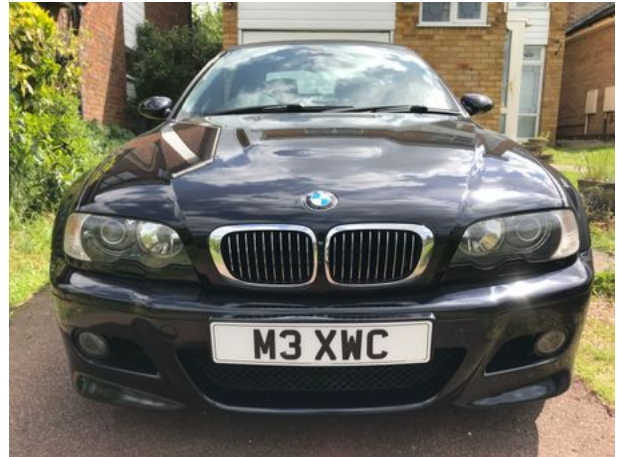
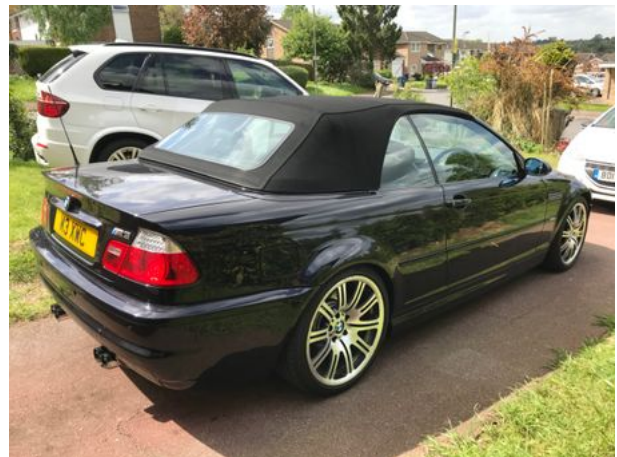
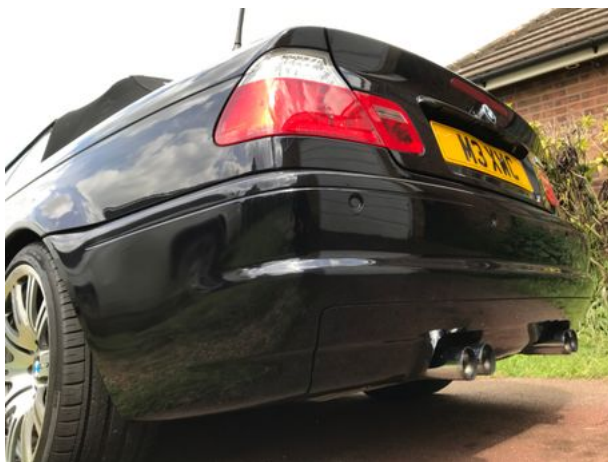
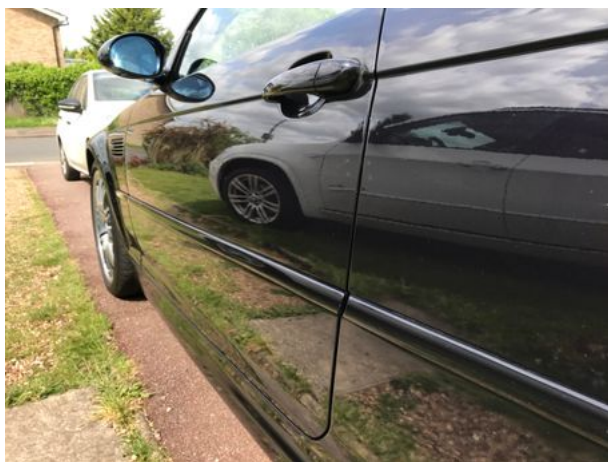
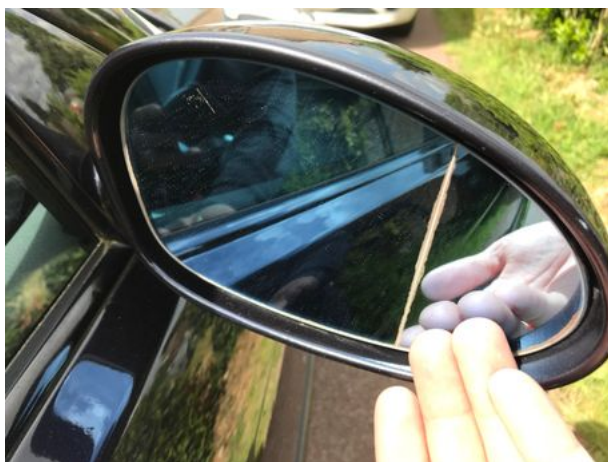
| Question | Response | Details |
|---|---|---|
| Condition de la carrosserie / Bodywork condition ? | Moyen / Medium | <p>Bodywork - car had full respray, job not bad, 7/10 but considering the age its fairly clean and looks nice and shiny</p> <p>In detail:</p> <p>bodywork respray not perfect, the actual preparation before repaint was rough and you can see it through the paint if come close, but car does look really clean from outside and shiny! So if you dont mind about being an investigator of whats hidden under the paint coat, then its nothing to worry about.</p> <p>Possible repairs on rear of car, also most likely during the respray job all minor dents and dints was filled on most body panels to bring back a better look, but you dont see any of that if not going very close and look with professional eyes.</p> <p>Bootlid disalighned slightly with a bit bigger gap on left side</p> <p>Very minor marks on bodywork on most panels, but nothing major, mainly very light stonechips and few dints, not even dents</p> <p>Near areal some paint chepped off</p> <p>Wing mirrors glass starting to become defective from age</p> <p>Left mirror holder plate have corrosion under paint , I think the plate is from alloy, so it may not been prepared very good before respray. But its easy job to repaint, if you take mirror off and sand it off then respray.</p> |

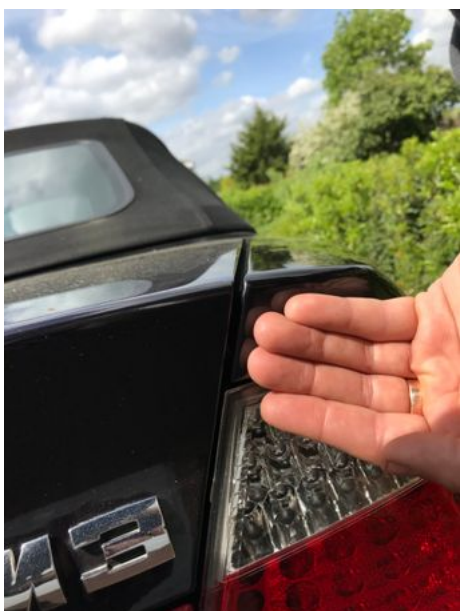
Appendix 40

| Question | Response | Details |
|---|---|---|
| Trace d'accident / Sign of accident ? | possible | Possibly had light tap on rear as bootlid not aligns against rear wings |

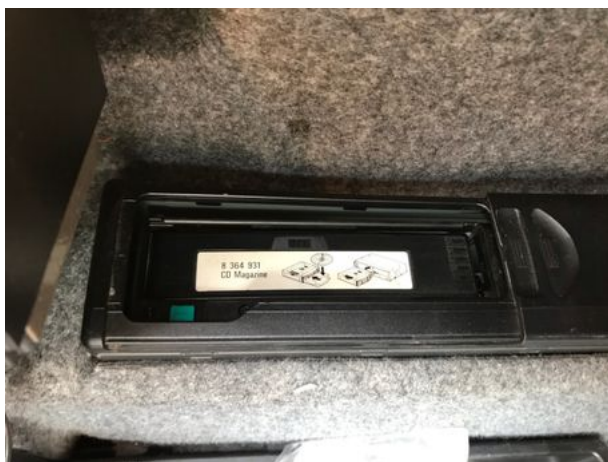
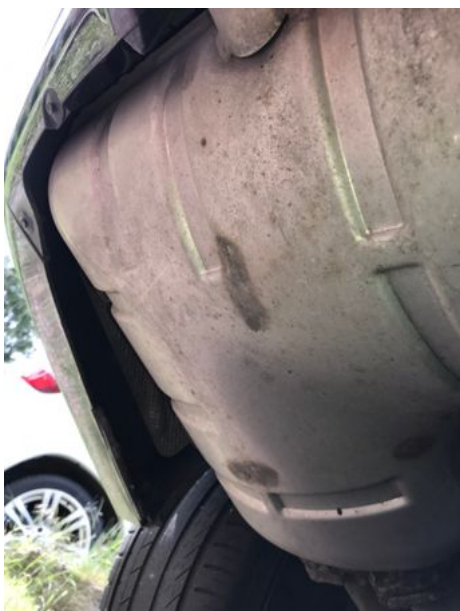
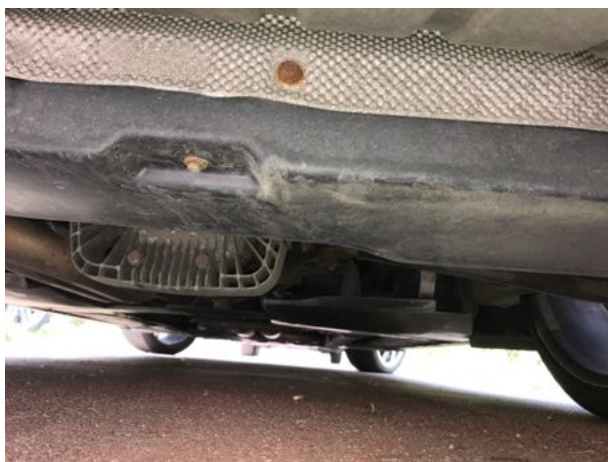
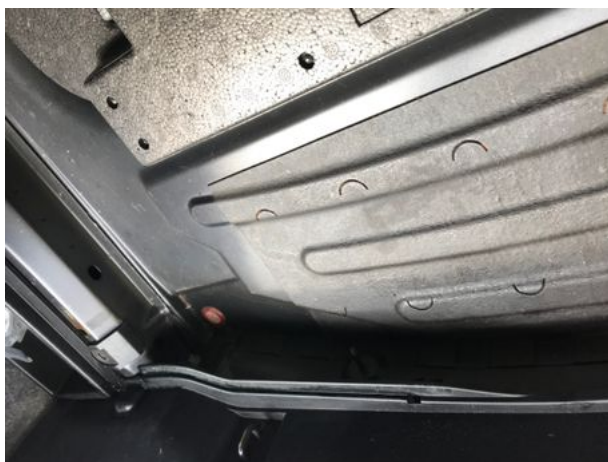
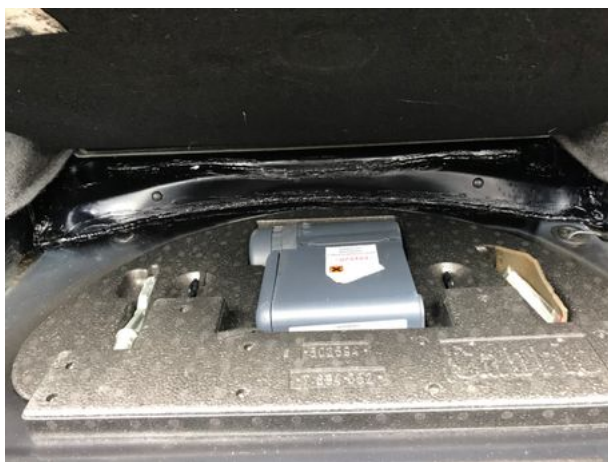
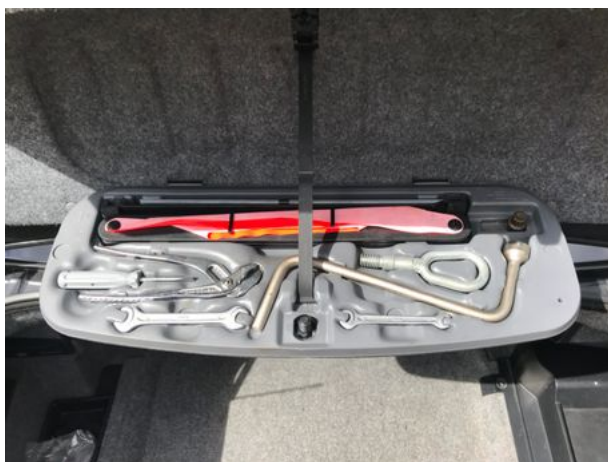
| Question | Response | Details |
|---|---|---|
| Le coffre souffre-t-il de déformations, réparations ou corrosion / Boot showing signs of deformations, repairs or corrosion ? | Yes | Boot are ok for age, carpet got some marks and handle on inside of boot floor cover got crack on plastic housing. Chassis in boot looks good, visible repairs on top where the subframe and main chassis joins. So as the seller stated this car had strengthening welds done by the garage. |

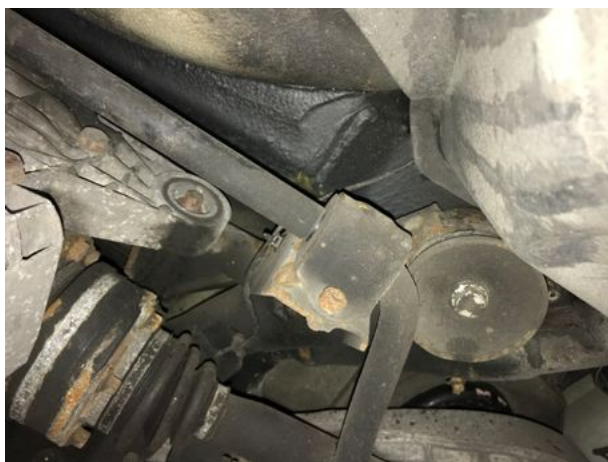
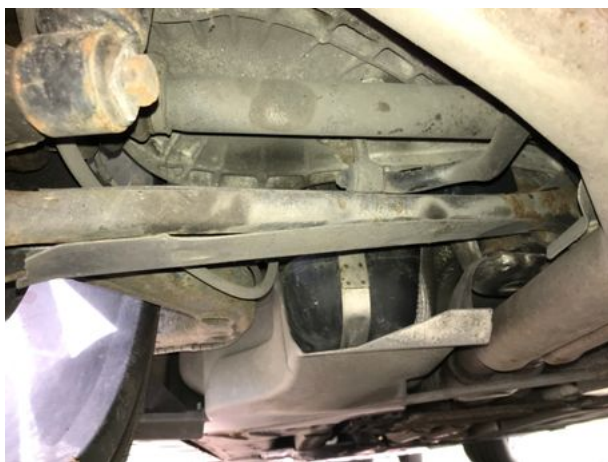
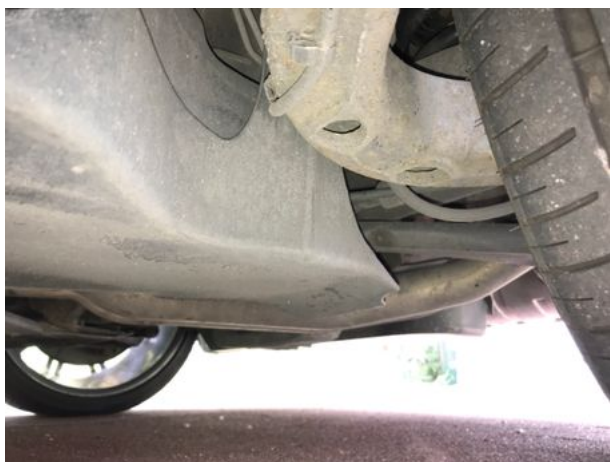
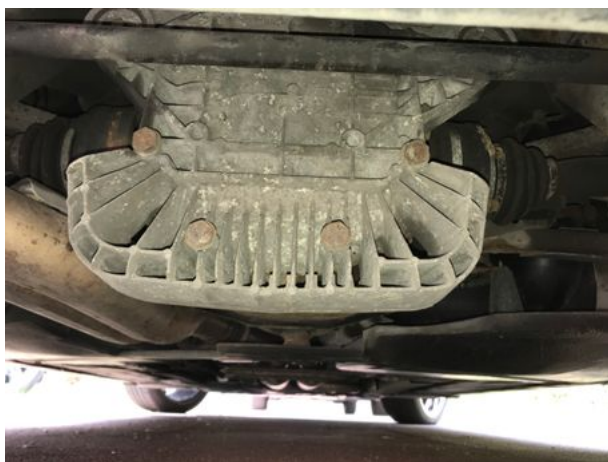
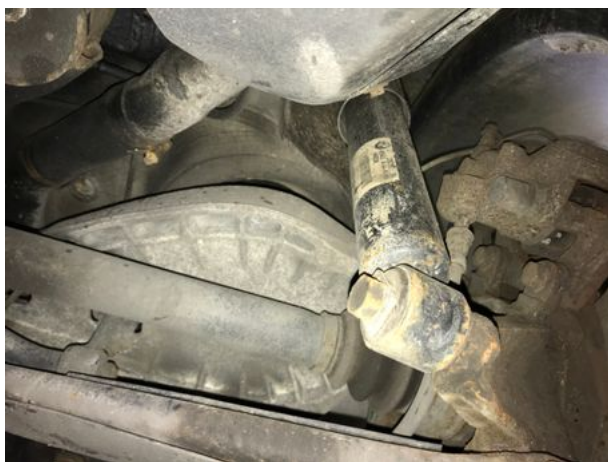
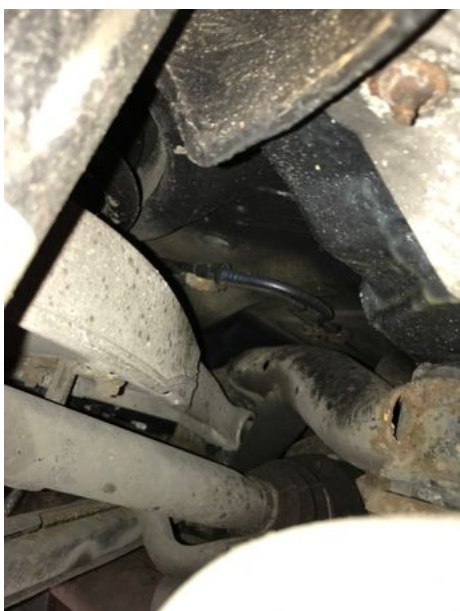
| Question | Response | Details |
|---|---|---|
| Corrosion du châssis / Chassis corrosion ? | Bien / Good | <p>Under chassis most covered with plastic shields, but as far as I could see, it all looks good! Minor corrosion in some places, but all very solid and no visible damage!</p> <p>Under rear subframe same as in boot, it can be seen repairs with some sort of plates welded on to add strength!</p> <p>Exhaust system got corrosion, but sounds ok, only thing is near exhaust headers possibly slight blow as if to listen from bottom of car ticking sound comes more from that side.. can not see much from ground, so this would needs to be looked on ramps.</p> <p>Suspension, diff, all looks ok for that age and mileage. Rubbers got aging, but looks all intact. Minor corrosion on all parts, but nothing excessive.</p> <p>Dont see any oil leaks from underneath, all looks dry.</p> |

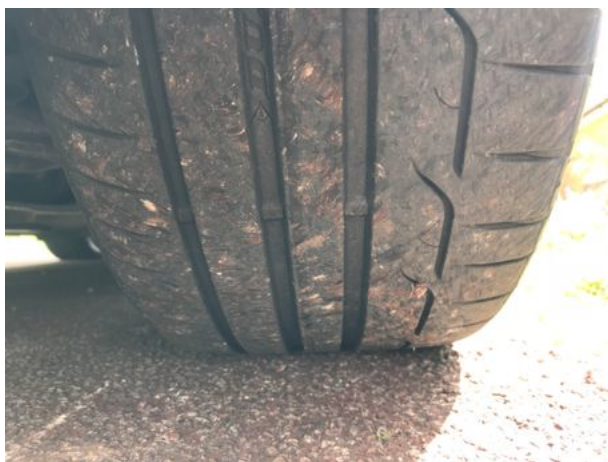
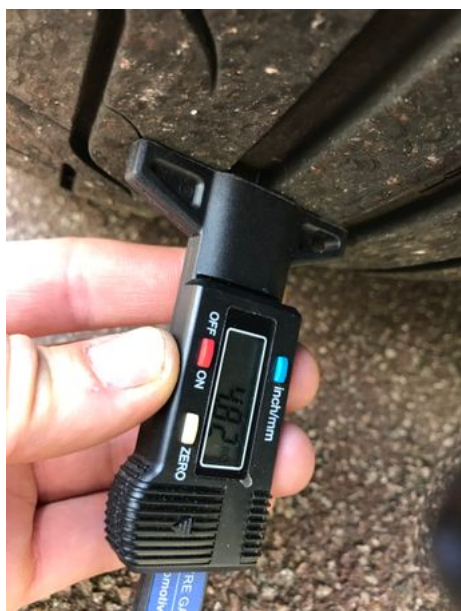
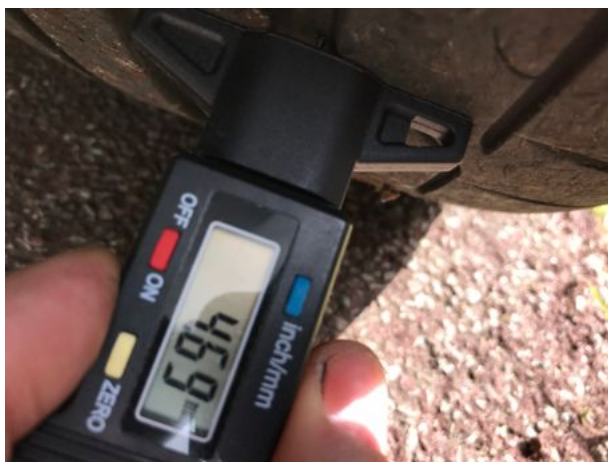
| Question | Response | Details |
|---|---|---|
| Etat des pneus avant / Front tyres condition : | à prévoir / to do at next service | Wheels got marks, curbs, scratches, but looks straight and ok for age. Tyres I would recomend to change soon, because fronts starting to crack from age, but still got approx 4mm of tread |

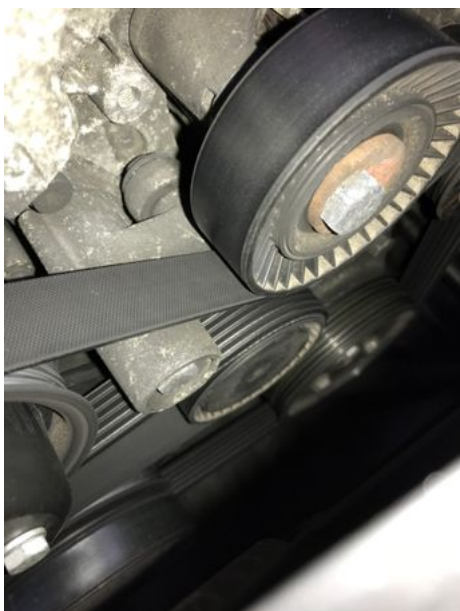
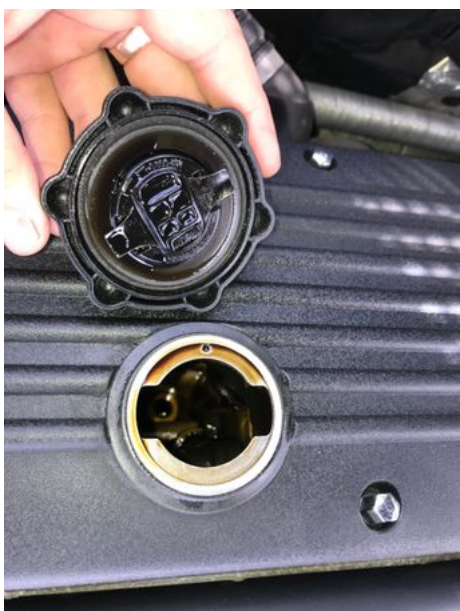
| Question | Response | Details |
|---|---|---|
| Etat des courroies / Belts condition (timing & auxiliary): | à faire vérifier / to be checked | Belts would need further check when car is on ramps.<br>Timing chain sound ok, no excessive noise |

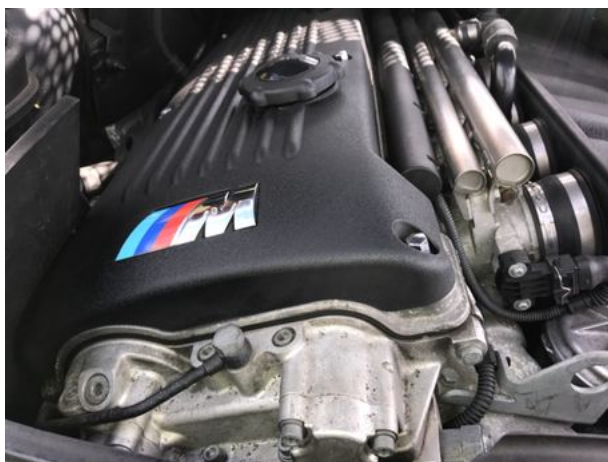
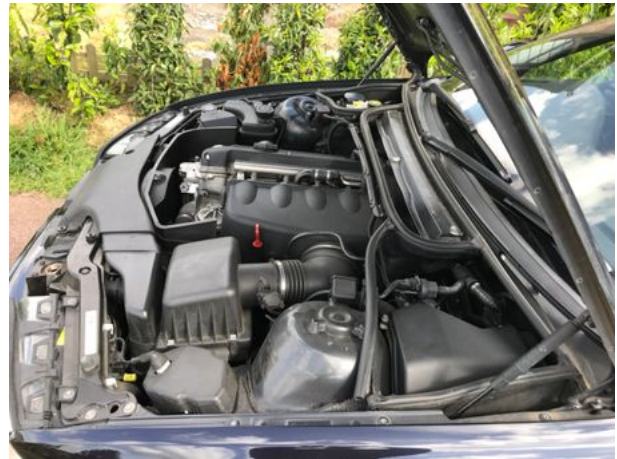
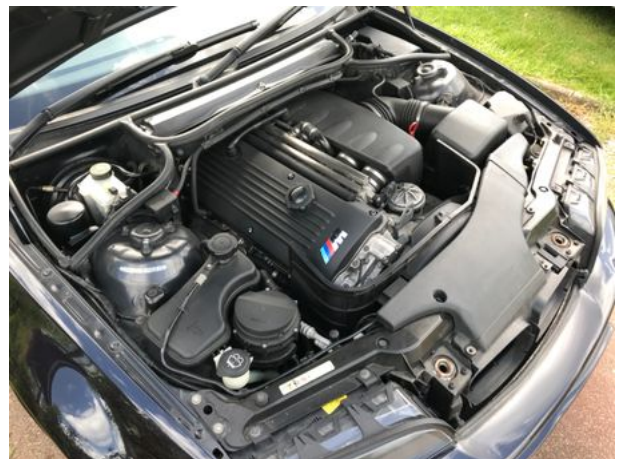
| Question | Response | Details |
|---|---|---|
| Etat général baie moteur / General condition engine bay ? | Bien / Good | <p>Engine bay looks fully original and unmodified. Fairly clean for the age and mileage of the car at 95k miles. Usual dust, minor dirt and very minor rust spots in some places.</p> <p>No visible oil leaks and engine looks clean.</p> <p>Engine starts on cold and hot as it should!</p> <p>Engine works and sounds ok, no strange noises or bangs, only slight ticking and tapping from cylinder head valve train. Its not perfect, but good for the mileage it have.</p> <p>No smoke from oil filler cap, only very slight puf, but oil got warm, so it all good!</p> <p>No smoke from exhaust either, only minor condensation, so its all sounds good!</p> <p>Engine revs up nice and sharp!</p> <p>Engine ticking sound, not major and probably will still be there after you done 100k and will not affect anything.</p> <p>Power steering reservoir bottle is greasy and steering fluid pipes are covered in grease. This is common and not a problem, it was building up iver long period and knowns as hoses do get very slight leak near connections with bottle, but usually its so luttle, that can go for years without the need to top up the fluid. However when car be on ramps, I would advise to double check from underneath and try to tighten the hoses. Also clean them so if there be any nee leaks, then it can be tracked easier.</p> |

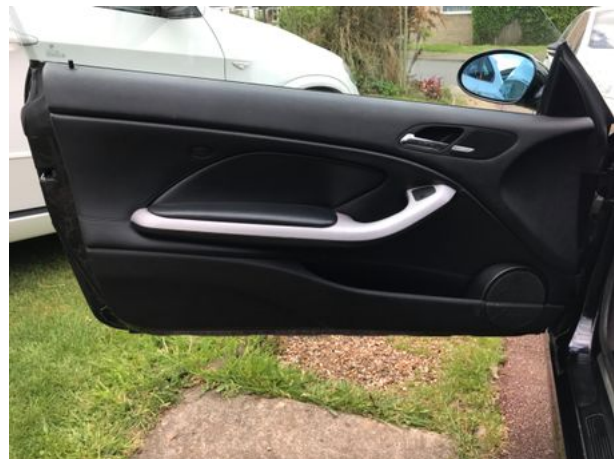
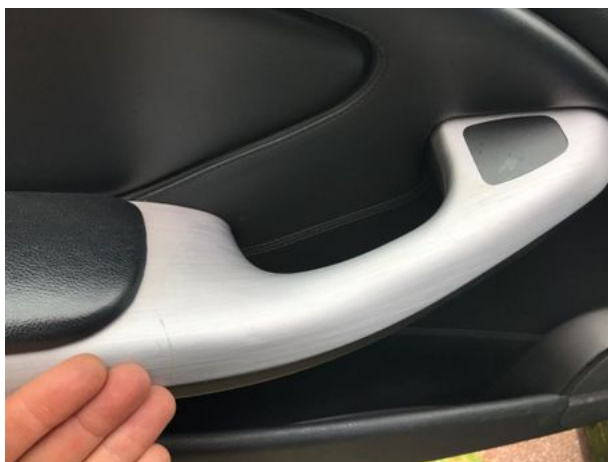
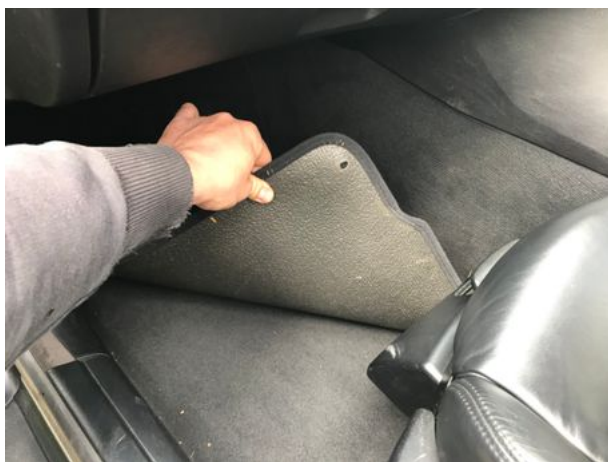
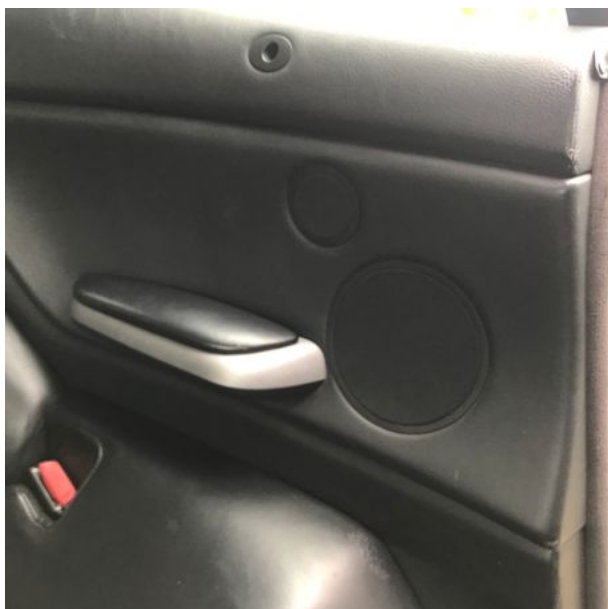
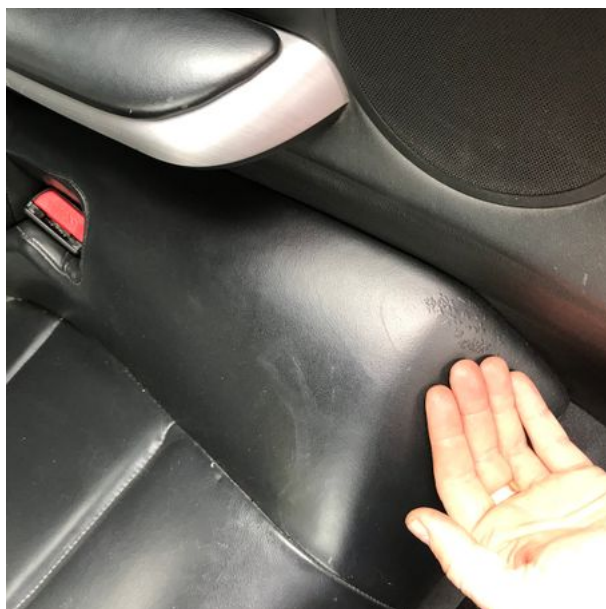
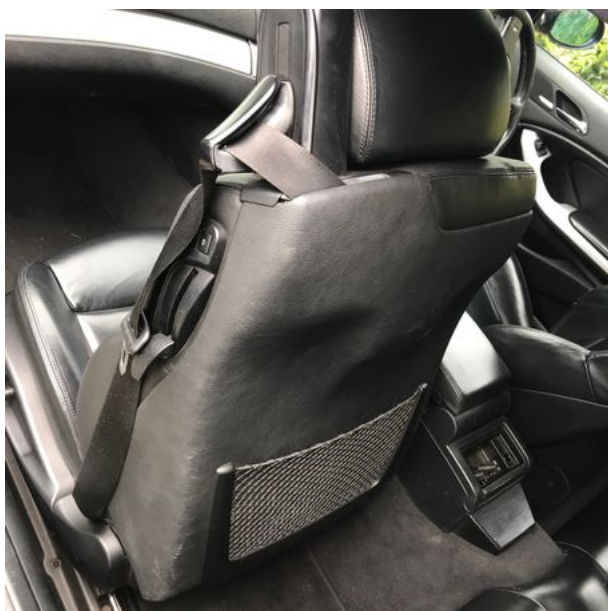
| Question | Response | Details |
|---|---|---|
| Etat de l'intérieur / Interior condition ? | Moyen / Medium | <p>Interior - not perfect, needs a good clean, seller did not prepare car for sale, so with full wallet it would look much better.</p> <p>Mainly downpoints are usual wear and tear to most parts, scratches on all plastics and leather.</p> <p>Driver seat have more wear on side edge and slight split on stitching, but this can be repaired by stitching it up.</p> <p>Tv screen got some dead pixels</p> <p>AC seems all working as it should</p> <p>Left rear window seal have rubber bit missing on top</p> <p>Cabrio roof needs clean from outside with conditioner to bring black colour back.. its not bad though comparing to others</p> <p>Inside of interior the cabrio roof lining on right side not intact</p> |
