# Inspection Convertible Gocarz

## M3XWC

11 May 2018 12:38 PM

BMW M3 E46

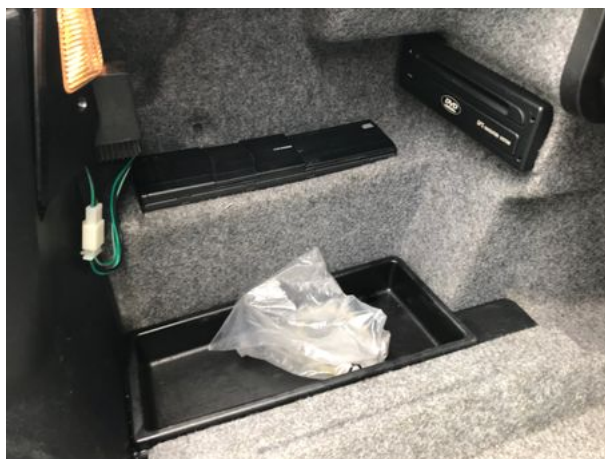
Appendix 42

| Question | Response | Details |
|---|---|---|
| Le coffre souffre-t-il de déformations, réparations ou corrosion / Boot showing signs of deformations, repairs or corrosion ? | Yes | Boot are ok for age, carpet got some marks and handle on inside of boot floor cover got crack on plastic housing. Chassis in boot looks good, visible repairs on top where the subframe and main chassis joins. So as the seller stated this car had strengthening welds done by the garage. |
